All models

Note: When performing this job number, the engine compartment lower panel or the noise encapsulation panel must be removed on models 124.1/3 and 201.1, and replaced after completing all maintenance work (refer to job number 6190 or 9490).

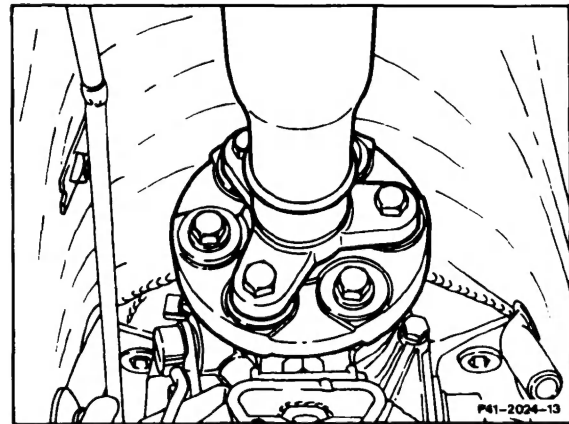
Model 107, 123, 126.03/04

Model 123 1st version through 09.1980 on vehicles with 6 cylinder engine

- Check flexible coupling for wear and damage, as well as for distortion (visual inspection).
- On those flexible coupling mounted at the transmission end, that are radially soft (soft in thrust) and tangentially soft (soft in thrust and tension), check the lands in the area of the dowel sleeves (arrows) for cracks (visual inspection).
- Replace flexible coupling if damaged or worn.
- If distortion is found, loosen and retighten drive shaft. If distortion remains, replace flexible coupling.

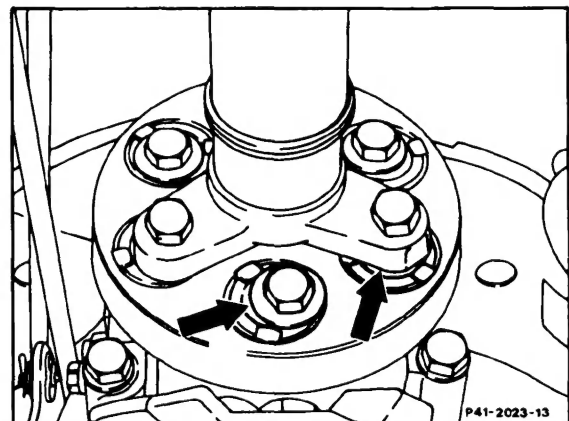
Model 126.02 with radially softer flexible coupling (transmission end only)

Model 123 2nd version starting 10.1980 on vehicle with 6 cylinder engine

Tangentially softer flexible coupling, front and rear, on model 123 with 5-speed manual transmission
Starting 10.1985 model 126.02 at transmission end only

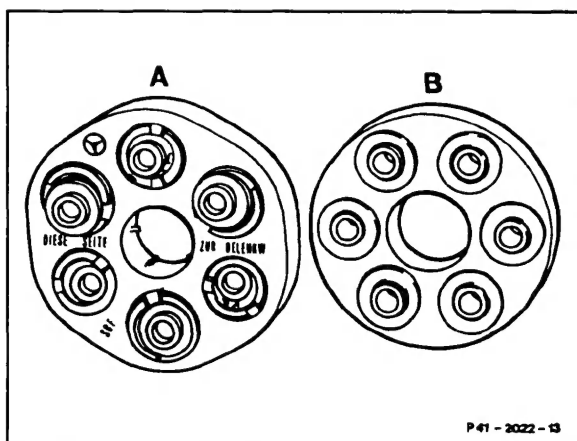
Models, 124.036, 129, 140

- C Model 129.060 (90mm bolt circle), 129.061, 140.03 (100 mm bolt circle) torsionally rigid
- D Model 124.036, 129.066, 140.04/05 (110 mm bolt circle) 4 arm flange and torsionally rigid
